# Research Study on the Sinking Sequence of MV Estonia

WP2.2 Definition of foundering scenarios  
WP3.5 CFD Computations and validations  
WP4.1 Comprehensive modelling of MV Estonia

Project No.: *SaS0603-VIES01*  
Reference No.: *VIES01-RE-001-AJ*  
Report Date: *09 September 2006*  
Report Type: *FINAL*  
Report Status: *CONFIDENTIAL*

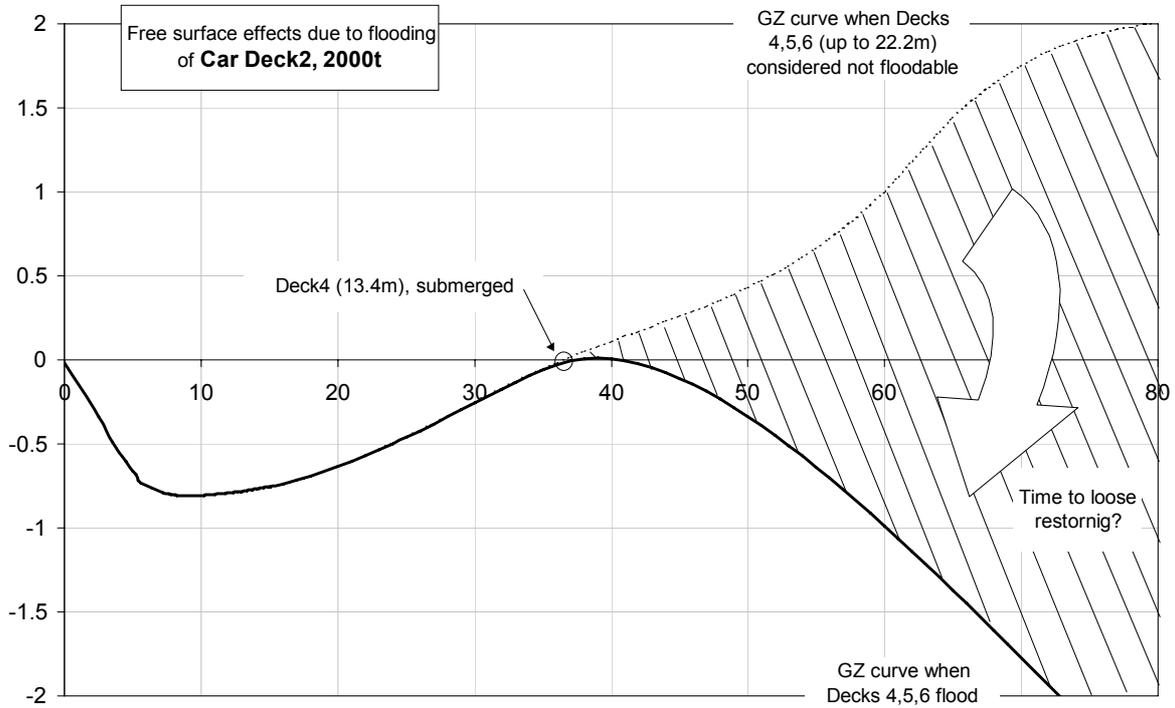
In conclusion, this pilot study proposed new mechanism for flooding of spaces below the car deck, BUT it failed to demonstrate the ability of the vessel to stabilise at heel angles of more than 40deg for more than 2-3 minutes<sup>4</sup>.

Figure 1: The process of flooding Decks 4, 5 and 6 takes place within a finite amount of time, estimated 13-28minutes if the JAIC statements were used as a reference base.

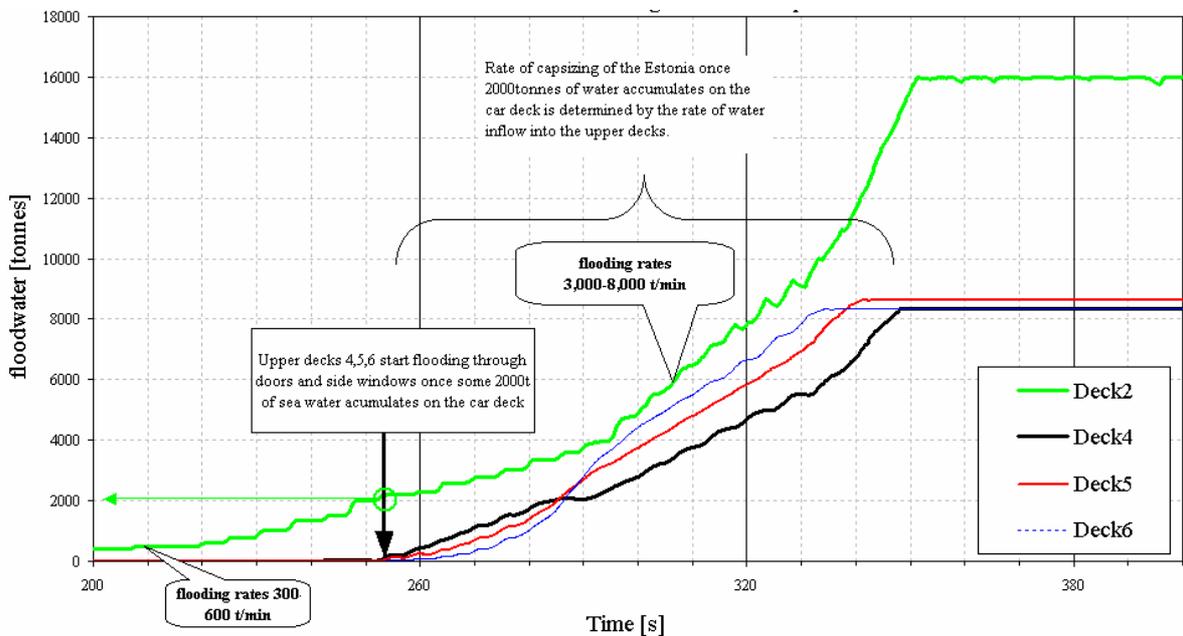
Figure 2 Estonia, Run136 (Figure 14 of [ 4 ]). Simulated typical flooding into Decks 2 (Car Deck) and Decks 4, 5 and 6 based on the JAIC scenario description. 15 windows assumed broken on each of upper decks with a total area of 20 m<sup>2</sup> for each deck. Car deck flooded through forward ramp.

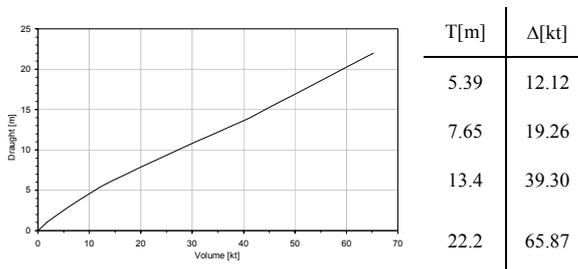
Figure 3: Underwater volume of the MV Estonia hull as a function of draught.

As can be seen in Figure 3, for MV Estonia to sink, with a capacity up to the top of the sixth deck at 22.2m of approximately 65,870 tonnes, a weight of 53,670 tonnes has to be added to her approximately 12,200 tonnes. Without going into details of permeabilities and exact geometries of the floodable spaces, this volume can be composed by flooding the accommodation decks 4, 5 and 6 collectively having a total capacity of approximately 26,000 tonnes, the car deck space with a capacity of about 20,000 tonnes including central casings (see Table 1 to Table 4 for more accurate estimates of the actual volumes of floodable spaces) and approximately 7,700 tonnes below the car deck space. Only then would the vessel lose her floatability.

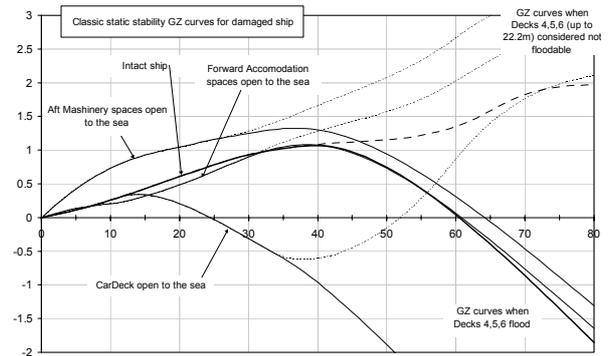
Figure 7: Classic static stability GZ curves for damaged ship

Figure 7 has been provided to demonstrate the properties of the GZ curves when flooding is considered in classical damage stability terms, that is when at every stage of flooding equalisation is reached between the floodwater level in the ship internal spaces and the outside sea. Little use can be made of such information in studies on ship behaviour as discussed here, as the process of this flooding is of fundamental importance in understanding the sequence of events leading to capsizing and/or sinking. Therefore, common assumptions of immediate flooding of the damaged spaces must be abandoned hereafter and consideration given to time factor in this process. This reasoning must address all spaces subjected to flooding, and in case of MV Estonia these are the spaces below the car deck, the CD itself and accommodation Decks 4, 5 and 6.

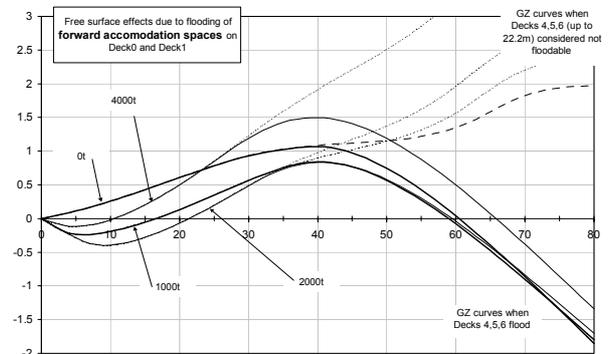
Figure 9: Free surface effects due to flooding of FS

Returning to free surface effect, Figure 9 demonstrates the ship restoring properties after partial flooding of spaces forward on Decks 0 and 1. Water is assumed to be uniformly distributed between the nine compartments, an overly conservative assumption, as normally the water would flow down to Deck 0 filling it, and thereby increasing ship stability, GM, at equilibrium angles (steepness of GZ curve at intersection with horizontal heel axis). As can be seen the largest heel angle of about 21deg results when the floodwater in the FS amounts to approximately 2,000 tonnes.

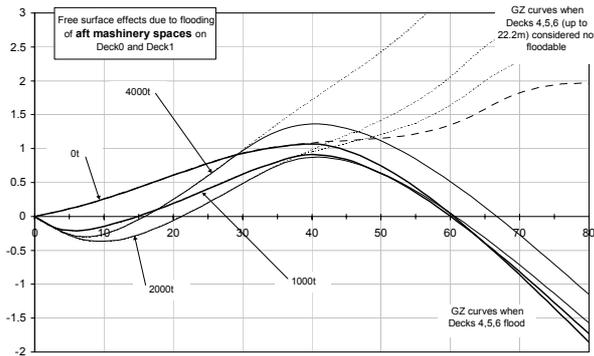
Figure 10: Free surface effects due to flooding of AS

In a similar manner it can be seen from Figure 10 that flooding of the aft spaces results in similar vessel stability characteristics as flooding of spaces forward, that is maximum heel of about 21deg is obtained with 2,000 tonnes of floodwater.

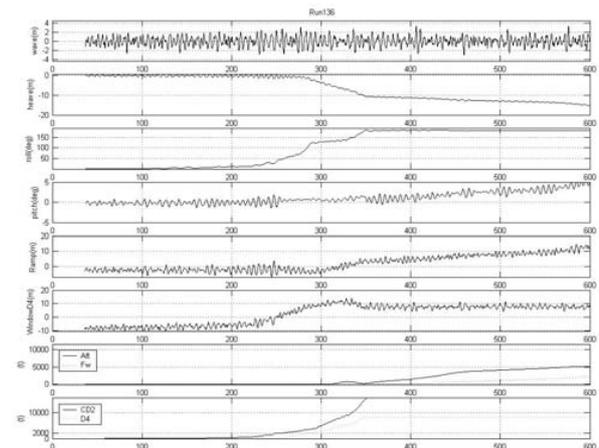
Figure 14: Time series of Scenario 1a: (1) wave, (2) heave, (3) roll, (4) pitch, (5) Relative motion at Ramp, [66.1, 0.0, 7.65], (6) Relative motion at the window in Deck 4, [-64.81, 12.11, 13.9], (7) Aggregate flooding into the forward and aft spaces below the car deck, (8) Aggregate flooding into the Car Deck and Deck 4.

It was found consistently that the vessel in such a scenario capsizes and floats upside down within 5-8 minutes from the beginning of the simulation. The average water inflow rates until an instant when 2,000 tonnes accumulates on the car deck, has been assessed to be between 300 and 600 [t/min]. Once the windows on Deck 4 become submerged (2,000 tonnes of water on the CD) the process of ship capsizing takes place within 2 minutes. A few hypothetical zero-speed cases considered revealed that the time to accumulate approximately 2,000 tonnes of water on deck increases approximately twofold. However, capsize still takes place within two minutes.

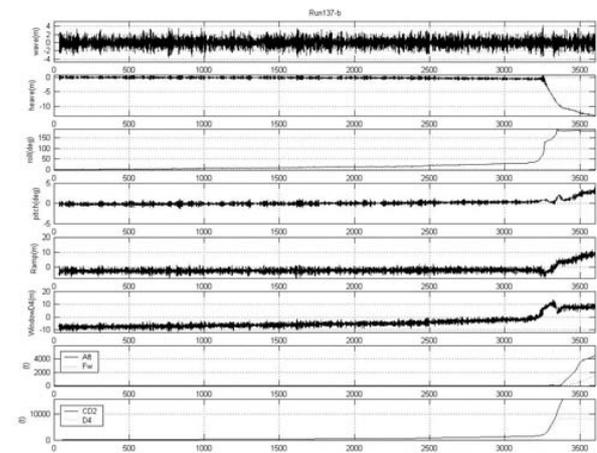
As can be seen in a typical example given in Figure 15, the time for the vessel to capsize is of the order of 45-60min. However, once the windows on Deck 4 submerge, the vessel capsizes within 2 minutes. This scenario on one hand confirms the uncertainty in assessing the rates of flooding the car deck, but on the other reaffirms the conclusion derived above that the JAIC description of sinking is lacking consistency. The vessel cannot float on her side with the superstructure flooded (as is taken for granted in JAIC statements), thus the spaces below cannot be flooded “from above”, and the vessel cannot sink.

Figure 15: Time series of Scenario 1b

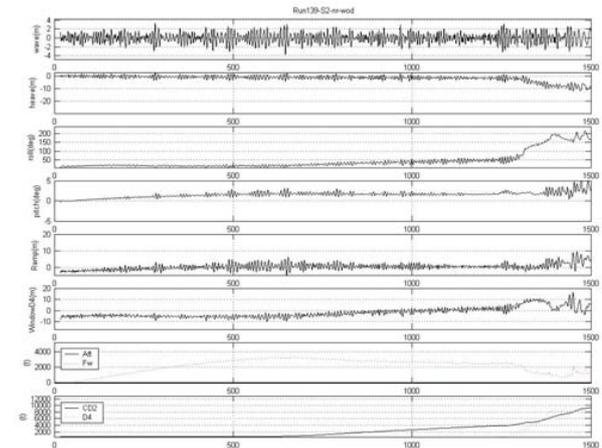
As is shown in Figure 17, approximately 3,200 tonnes of water accumulate in forward spaces within about 10 minutes from the start of the simulation, resulting in a trim angle of some 2-2.5deg by the bow and subsequent loss of the forward freeboard. The heel angle to starboard side reaches approximately 15deg. Water starts flooding the CD "from below" through the doors in the centre casing (assumed opened), leading to heel angles up to about 30-40deg within 5-10 minutes, when the windows on Deck 4 submerge. Once this takes place the ship capsizes within 1-2 minutes.

Figure 17: Time series of Scenario 2

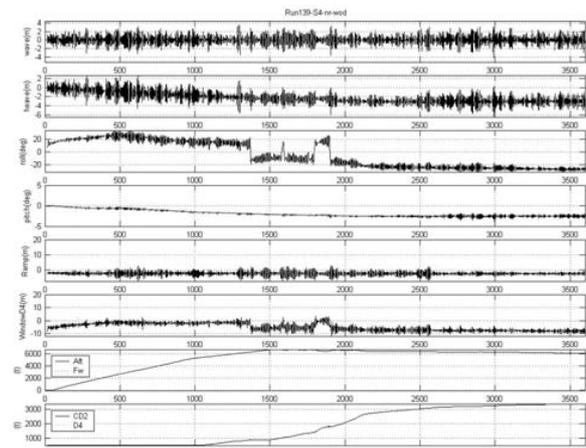
Note here, that sinking with the stern first is very likely a result of the mode/sequence of flooding of the upper decks. Namely, as the vessel lies on her side, the aft parts of the superstructure could flood faster than the forward, and hence she could sink stern first.

Figure 18: Time series of Scenario 3
