# Impossible Visor Scenario

## STATEMENT REPORT

**Subject:** Impossible visor scenario  
**Type:** Statement  
**By:** Björn Stenberg and Johan Ridderstolpe  
**Status:** Proved  
**Date:** 2000-01-01  
**Version:** Report excerpt - English

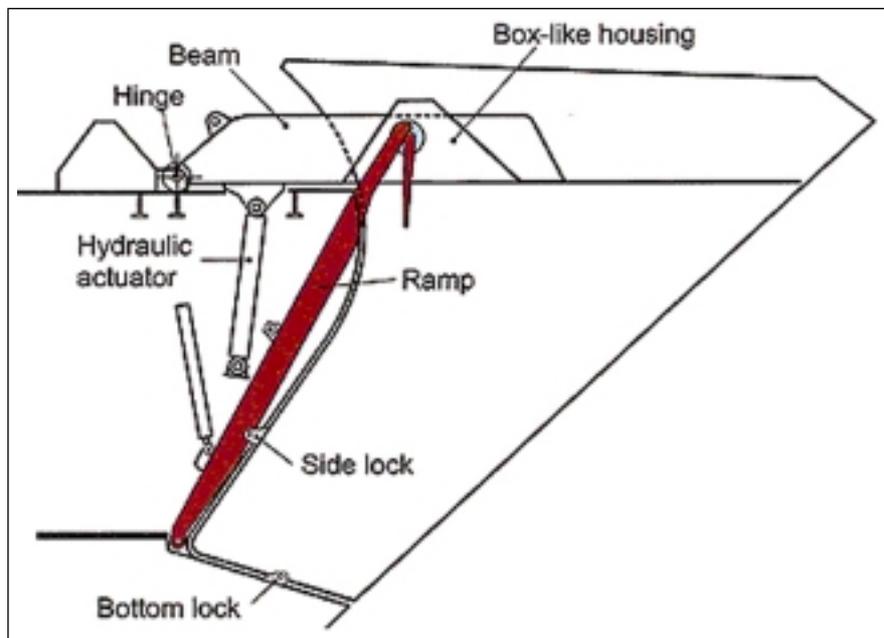
JAIC figure 3.5

When the ramp was closed, the visor enclosed the top part of the ramp.

The ramp was locked with six locking devices. On each side there were two hydraulic locking devices (pins) and one hydraulic locking hook, the latter also for pulling the ramp tight back when locking it.

However these locks are not shown in the JAIC figure 3.5.

The Commission here stated that "any side loads that might develop" are absorbed by the locating horns. After this correct statement they totally forgot all about the locating horns. They did not take in to consideration the load capacity of the horns and most important, the discharging effect of the wave impact loads on the visor locking devices.

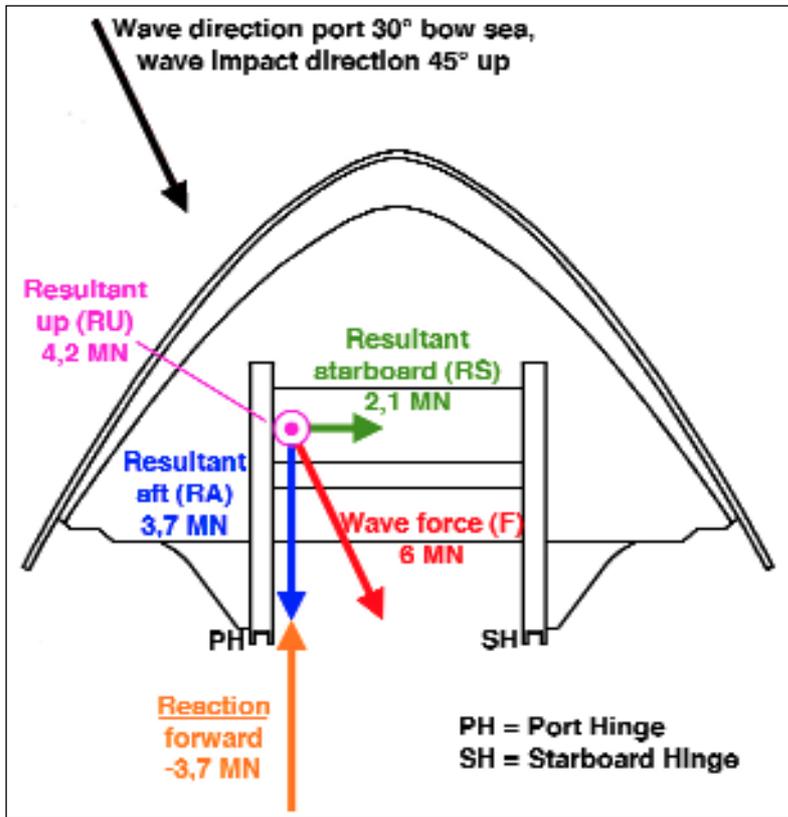
FG 2. Forces induced from bow sea.

The visor is shown from above, with a wave induced force of 6 MN in bow sea 30 degrees on the port side. The centre of the wave induced force was hitting the visor 4,5 metres over the normal water line in calm water, with an upward impact direction of 45 degrees. The resultants aft, starboard and up are shown in FG 2 below. The reaction force (forward) on the resultant RA 3,7 MN is shown.

No forward force was created from waves (unless the visor bounced back from the bulkhead). The rubber seal between the visor and the bulkhead had a total length of approximately 12 metres that could be compressed and could generate a bouncing effect. The stiffness of the seal was progressive. To compress the seal 10 mm would require a force of 10 000 N/m. To compress the seal 15 mm would call for 25 000 N/m (JAIC supplement 511). However the bouncing would only generate forces equivalent to a fraction of the visor weight as the "free motion margin" was only at maximum about 10 to 20 millimetres.

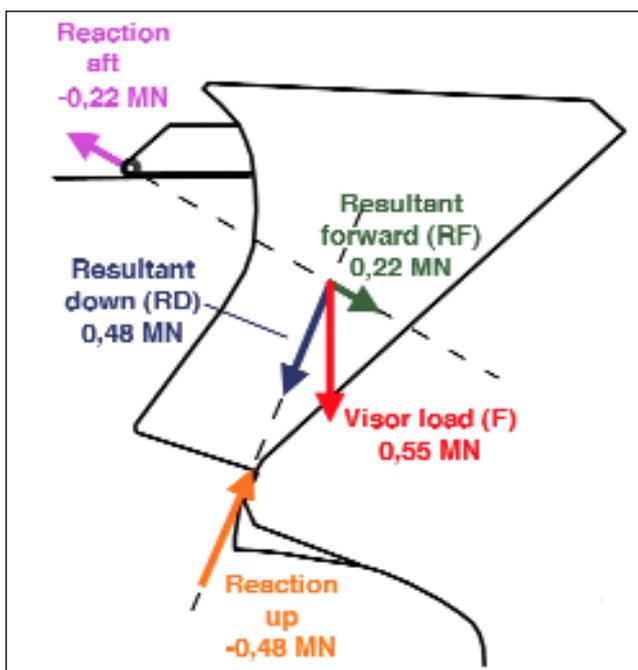
FG 3. Visor load force.

The visor seen from the starboard side. Theoretical force distribution between forward and down resultants. The visor was mainly resting on the forepeak deck. After the visor broke loose the forward resultant from the visor load was around 20 tons, but decreased to much less due to the hydraulic actuators holding the visor back.

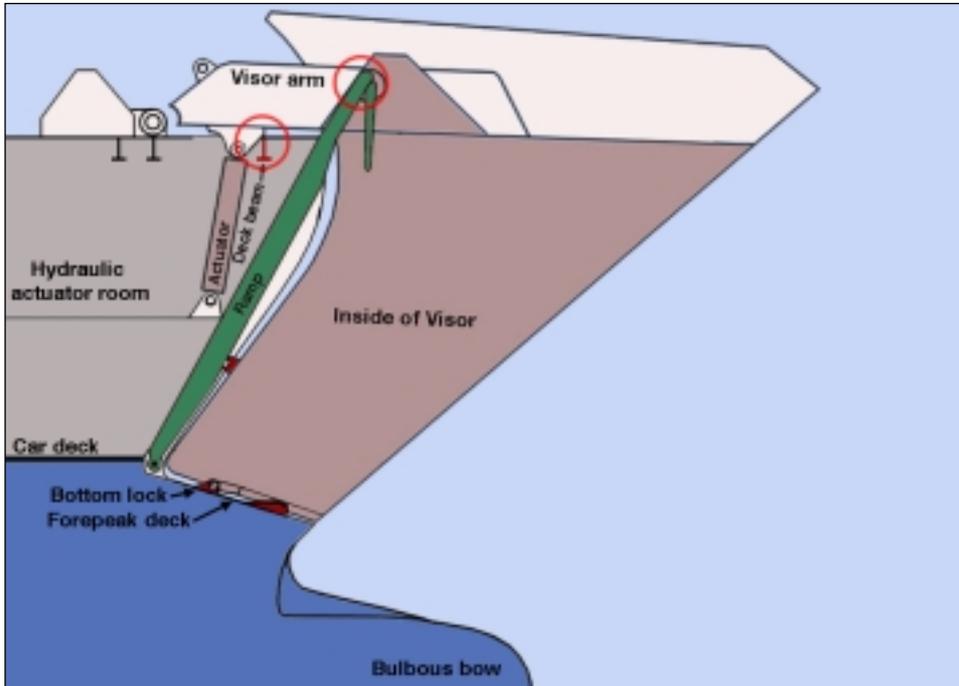
FG 4. The hinges on the visor arms broke and also the side lockings of the visor. The visor fell forward and the hydraulic lugs under the visor arms hit the deck beam (see also FG picture 6, A hitting B).

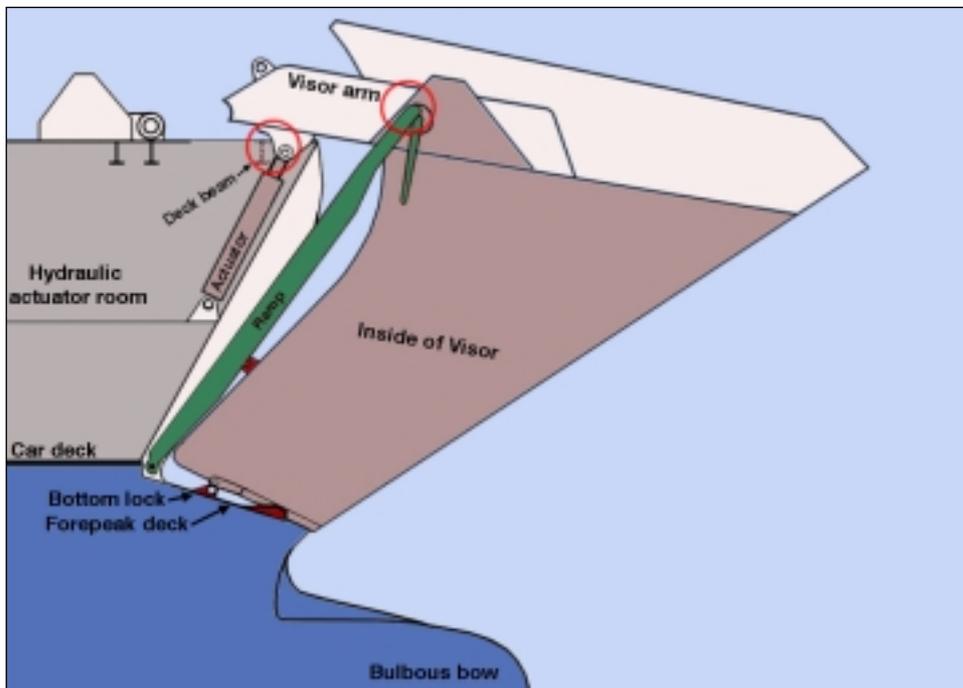
FG 5. The hydraulic lugs cut through the deck beam, and at the same time the visor housing hit the ramp and ripped it open (see also FG picture 6, C hitting D).

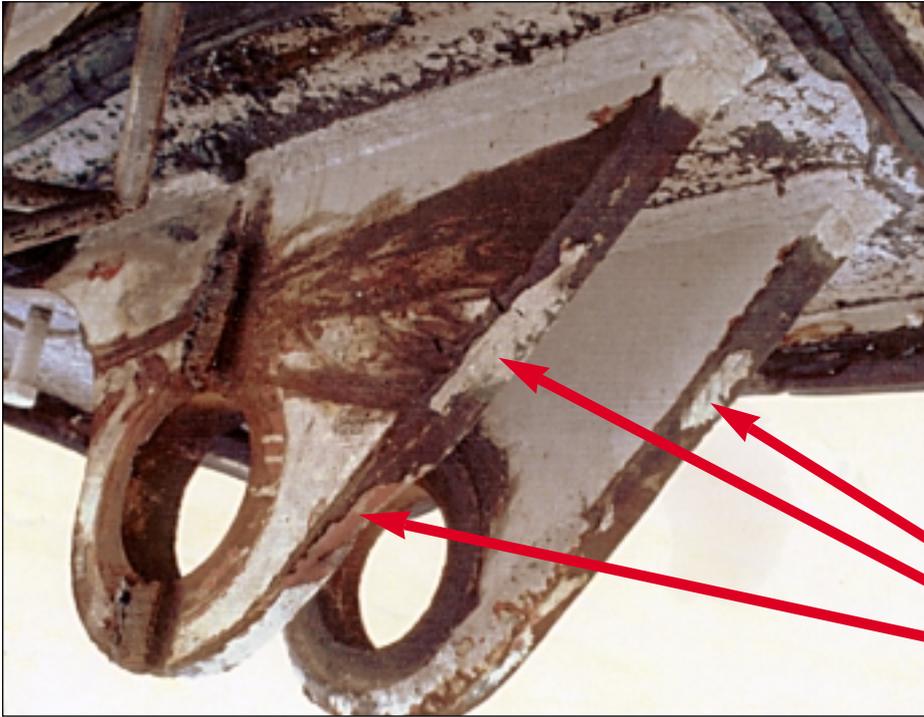
German Expert Group picture E9, No. 17 A. Lugs for dismantled port hydraulic actuator. On the lug to the left in the picture, the Commission adapted a vertical plate by welding and later cut this plate away. Note all the paint left on the surface that should have been in contact with the deck beam while cutting (arrows).

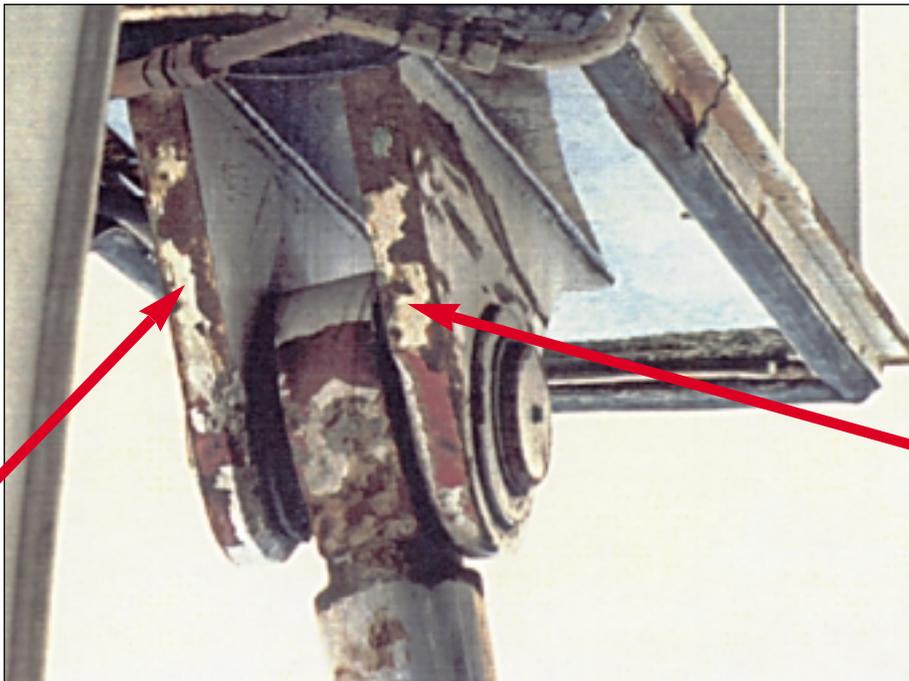
German Expert Group picture D8, No. 15 A. Lugs for starboard actuator.
