The Independent Fact Group

Recovery damage to the visor

STATEMENT REPORT

Subject: Recovery damage to the visor - an excerpt from the full report
Type: Statement
By: Johan Ridderstolpe and Björn Stenberg
Status: Proved
Date: 1 May 2000
Version: Report - English

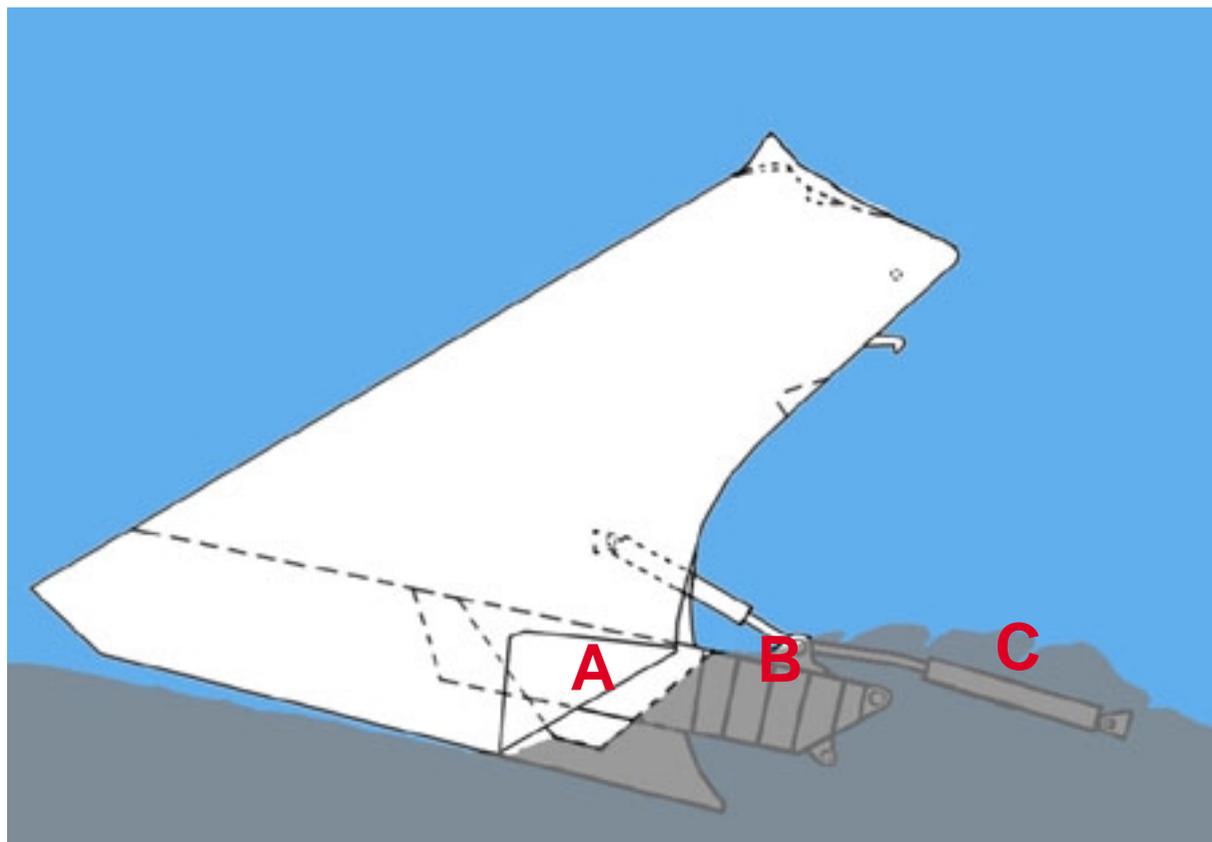
Picture 1. The picture shows the visor seen from the starboard side, standing upside down resting on the visor housing (A) with the visor arms (B) and the starboard hydraulic actuator (C) covered with mud. On the video (visiri) it can be seen that the rest of the visor was standing free from the bottom and that there were no contact marks on the bottom around the front of the visor.
