# Impossible Visor Scenario

## STATEMENT REPORT

**Subject:** Impossible visor scenario  
**Type:** Statement  
**By:** Björn Stenberg and Johan Ridderstolpe  
**Status:** Proved  
**Date:** 2000-01-01  
**Version:** Report - English

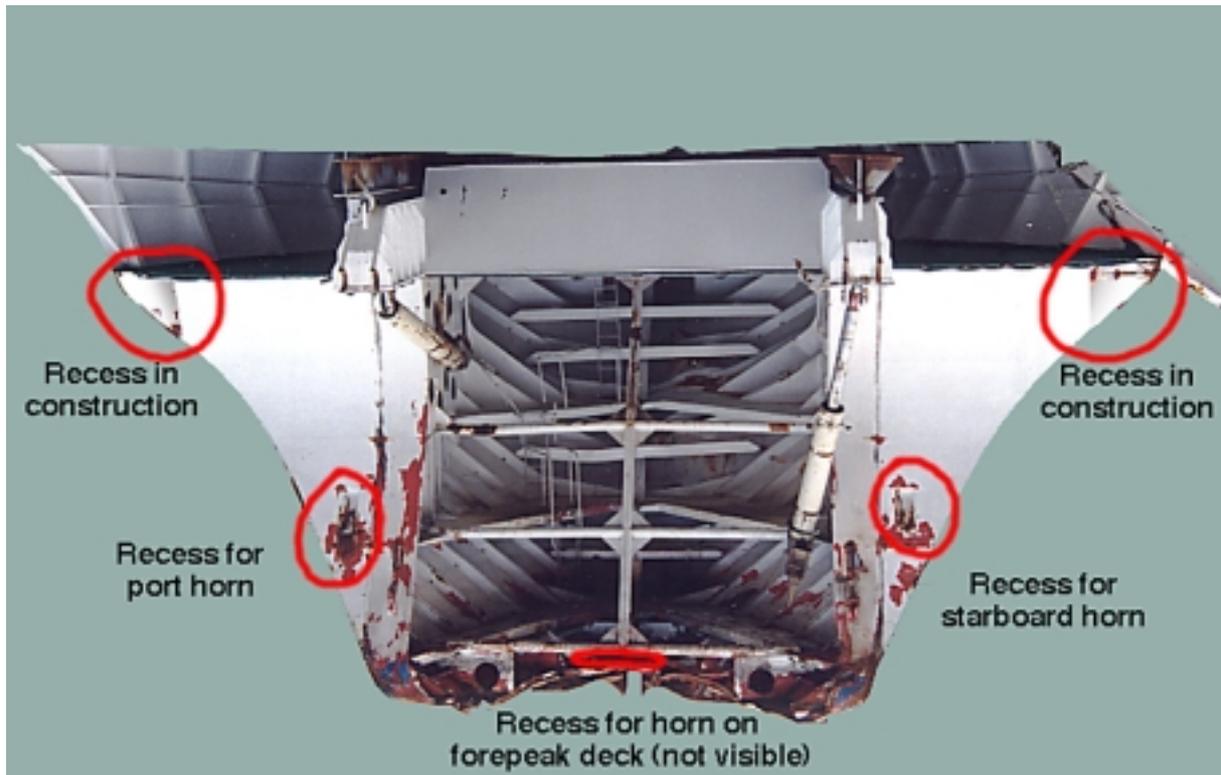
Fact Group (FG) picture 1. The picture shows the visor with its bulkhead to the left and right. The circles indicate the different positions for the recesses that would have absorbed any side loads.

The visor construction was such that, in addition to the three locating horns mentioned by the Commission, there are two upper recesses in the visor bulkhead where the visor engaged with the forward bulkhead in the closed position. This means that if the visor had come loose as a result of any side load, the upper part of the visor with the recess in the bulkhead would also have been damaged.

In reality, none of the recesses are damaged in the side direction.

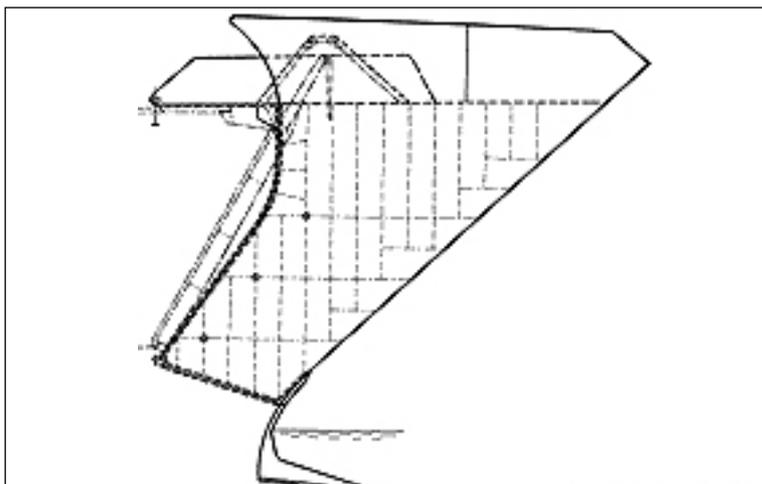
JAIC figure 3.6 (one of three views shown here)

It is also important to notice that the JAIC figure 3.5 and some other figures in the Commission report showing the ramp in the closed position are incorrect. The upper part of the ramp is "moved" aft so that it will meet the fore part of the upper deck. This illustrates the ramp being closer to the aft part of the visor housing for the ramp than it actually was. The most correct illustration in the final report is JAIC figure 3.6, "Bow visor general arrangement and structure".

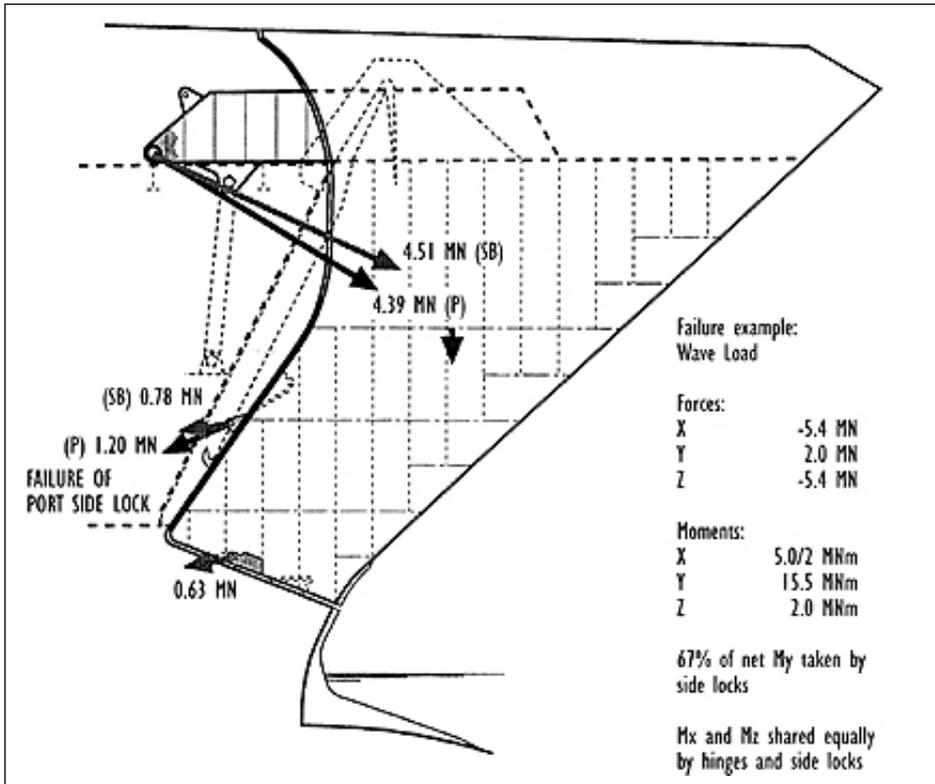
JAIC figure 15.4 "Example of reaction force distribution resulting in port side lock failure."

"....Figure 15.4 illustrates an example of a possible reaction force distribution over the attachments when the port side lock fails. The load on the hinges, though large, is acting in an uncritical direction while the bottom lock and the starboard side lock are loaded only to about half of the critical level."

The Commission failed to calculate the forces that acted on the visor. Instead of using the "resultant force" they used the "reaction force" to prove what force initially broke the visor attachments. They wrongly concluded that the "reaction force" resulted in the port side visor lock failure. Their general conclusion from the supplement (below) also shows that it was based on "may", "could", "seems" and is therefore nothing more than estimates.

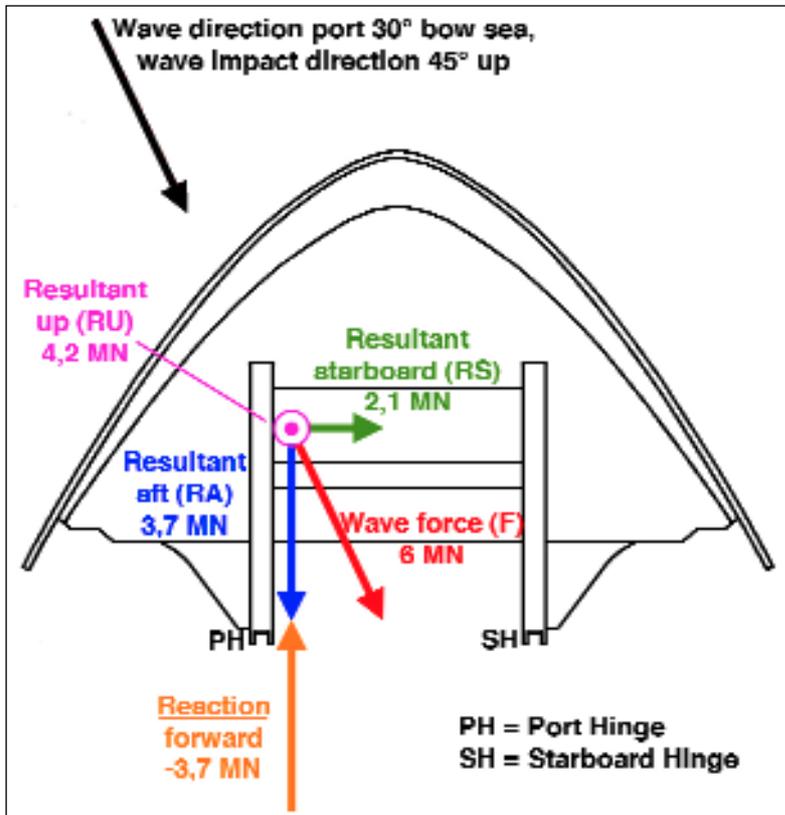
FG 2. Forces induced from bow sea.

The visor is shown from above, with a wave induced force of 6 MN in bow sea 30 degrees on the port side. The centre of the wave induced force was hitting the visor 4,5 metres over the normal water line in calm water, with an upward impact direction of 45 degrees. The resultants aft, starboard and up are shown in FG 2 below. The reaction force (forward) on the resultant RA 3,7 MN is shown.

No forward force was created from waves (unless the visor bounced back from the bulkhead). The rubber seal between the visor and the bulkhead had a total length of approximately 12 metres that could be compressed and could generate a bouncing effect. The stiffness of the seal was progressive. To compress the seal 10 mm would require a force of 10 000 N/m. To compress the seal 15 mm would call for 25 000 N/m (JAIC supplement 511). However the bouncing would only generate forces equivalent to a fraction of the visor weight as the "free motion margin" was only at maximum about 10 to 20 millimetres.

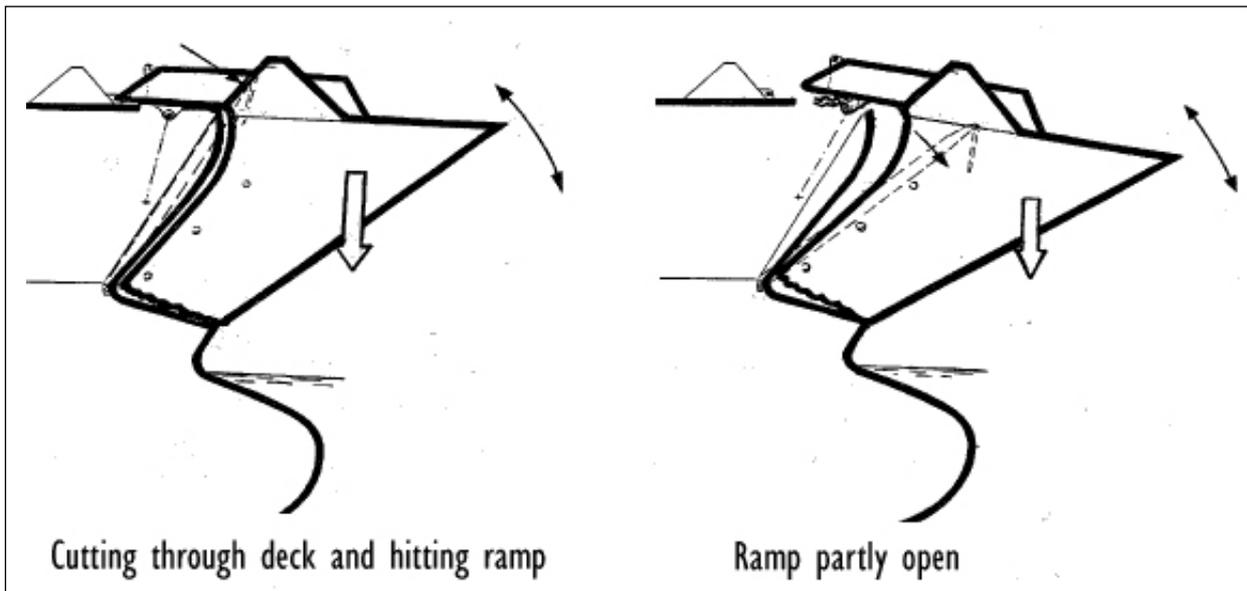
JAIC figure 13.6 (two of six drawings shown here)

...Subsequent wave impacts caused the visor to move backwards and forwards in combination with some vertical movements, resulting in various impact damage to the bulkhead and the hinge beams [read visor arms for hinges]. Impact marks indicate violent transverse movements, and upward movements of about 1.4 m. The damage is described in detail in Chapter 8. As estimated from impact marks on the aft edges of the visor hinge beams [read visor arms for hinges], the number of heavy aftward blows was at least two and probably less than five. The vertical wave force exceeded the weight of the visor on average once a minute under the prevailing conditions. The dynamics of this aft-forward movement of the visor generated sufficient impact forces to enable the hinge beam lugs to cut through the transverse deck beam, which was the heaviest structural element preventing the visor from moving forward.

It is important to note that the deck beam is not shown in JAIC figure 13.6 above, though it was found to be the "heaviest structural element preventing the visor from moving forward".

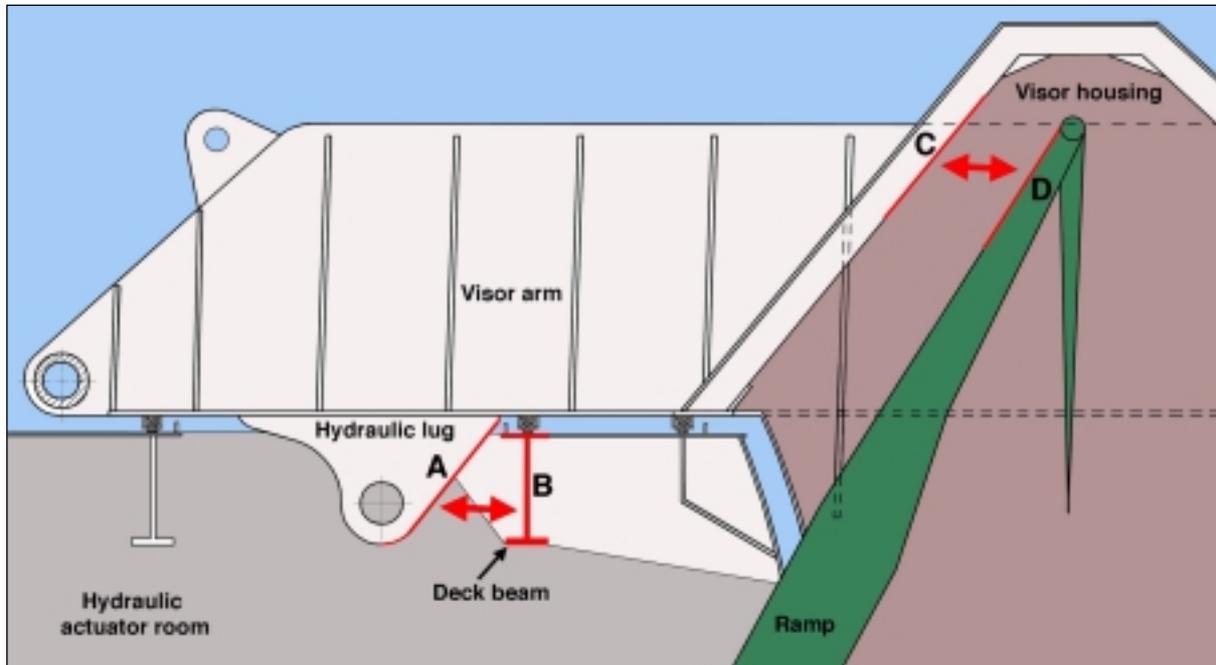
The deck beam was welded on the underside of the 8 mm thick foredeck. It was constructed like an "upside down T". The vertical plate was 400 mm high and 9 mm thick. The underside was 160 mm broad and 22 mm thick, welded to the vertical 9 mm plate.

FG 6. The picture shows the complete arrangement excluding the hydraulic actuator that was fastened to the hydraulic lug.

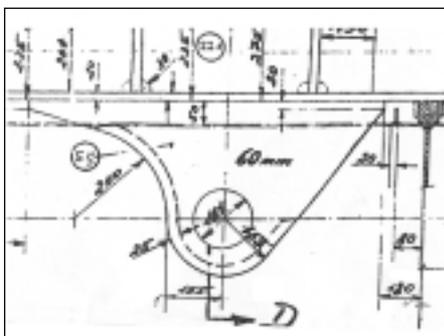
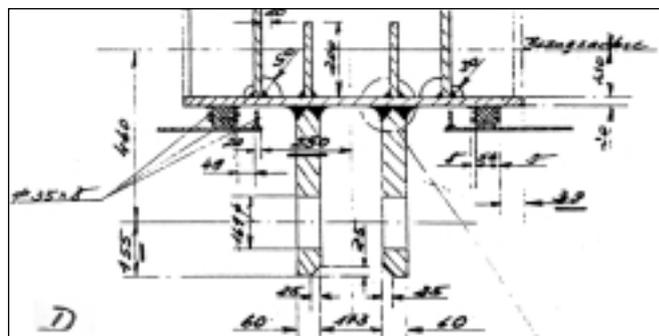
To be able to calculate the necessary force for cutting through the deck beam, we also have to look at the actuator lugs that are said to have cut through the beam. The "cutting edges" (A above and the red edge) on the two lugs (in this example the port side) were 60 mm wide, and the forward edge of the lugs was 455 mm high. The distance between the pair of lugs on the port side was 173 mm. The cutting angle relative to the deck beam was 38 degrees.

FG 7 and 8. The pictures show the dimension of the hydraulic lug seen from a side view and from aft. They are part of the Meyer Schiffswerft drawing of 2.6.1980.

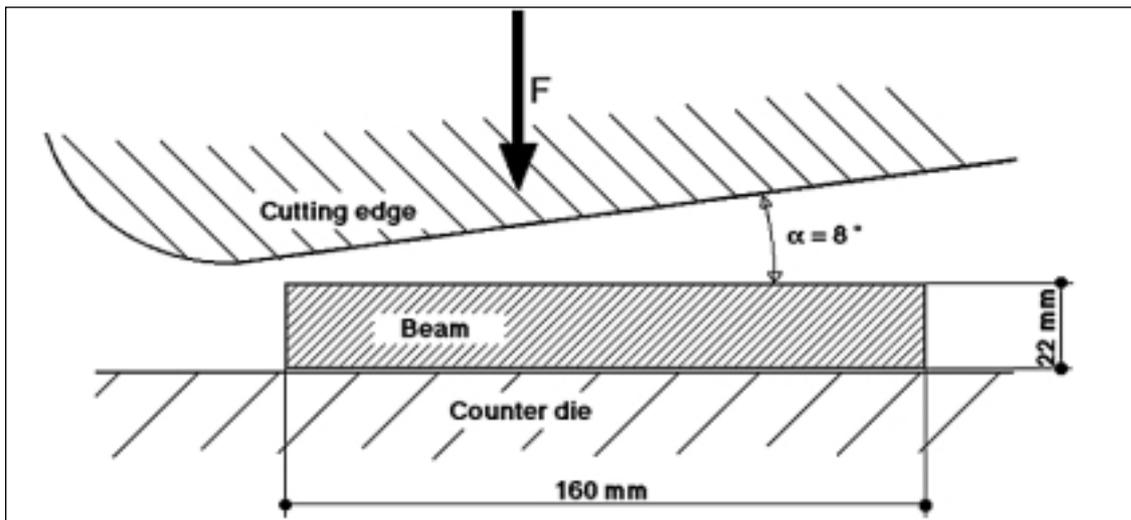
**Example 1.** Only cutting through the lower part of the beam, cross section 160 mm x 22 mm. In this example, we calculate the necessary force if the beam was cut in a professional cutting machine. This will ensure that we can estimate the lowest demand necessary to cut through the beam. Figures 9 and 10 show the cutting principle from the side and from the front. The cutting edge has the same dimensions as the hydraulic lug on the visor, but in this example it has a hardened edge. Our example only takes into account one of four necessary simultaneous cuts.

FG 9. The lower part of the deck beam seen from the side as in FG 6. The cutting edge represent the hydraulic lug, but the angle is changed to a relevant cutting angle, 8 degrees.  $F$  is the force we aim to find.

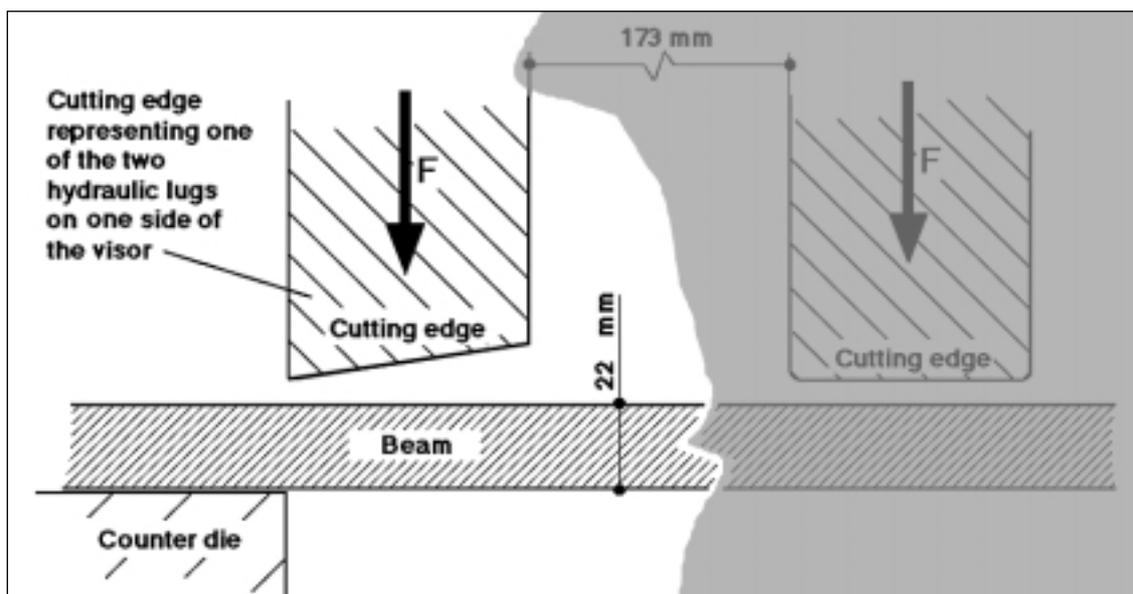
FG 10. The lower part of the deck beam seen from the front. In the grey area we show the other side of the hydraulic lug pair, that in reality also had to cut through the beam in the same "cut". Two hydraulic lugs on each side had to make a total of 4 cuts. Moreover, in real life, there was no counter die.

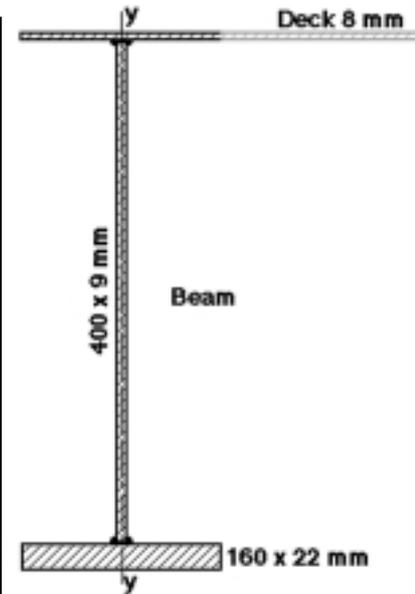
FG 11. Deck beam cross section

$$W_y = \frac{1}{6 \times 16} \times 12317 \Rightarrow \frac{1}{6 \times 16} \times 12317 = 128,3 \text{ cm}^3$$

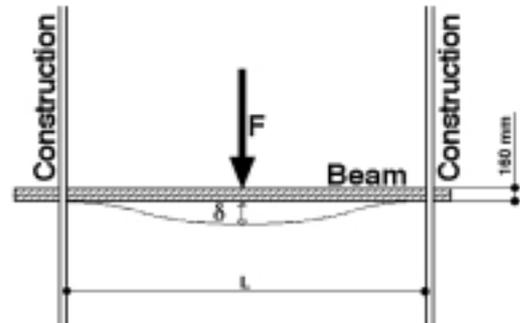
FG 12. Deck beam view from above.

$$\delta_{\max} = \frac{455412 \times 500^3}{3 \times 210000 \times 10260000} = 8,80 \text{ mm}$$

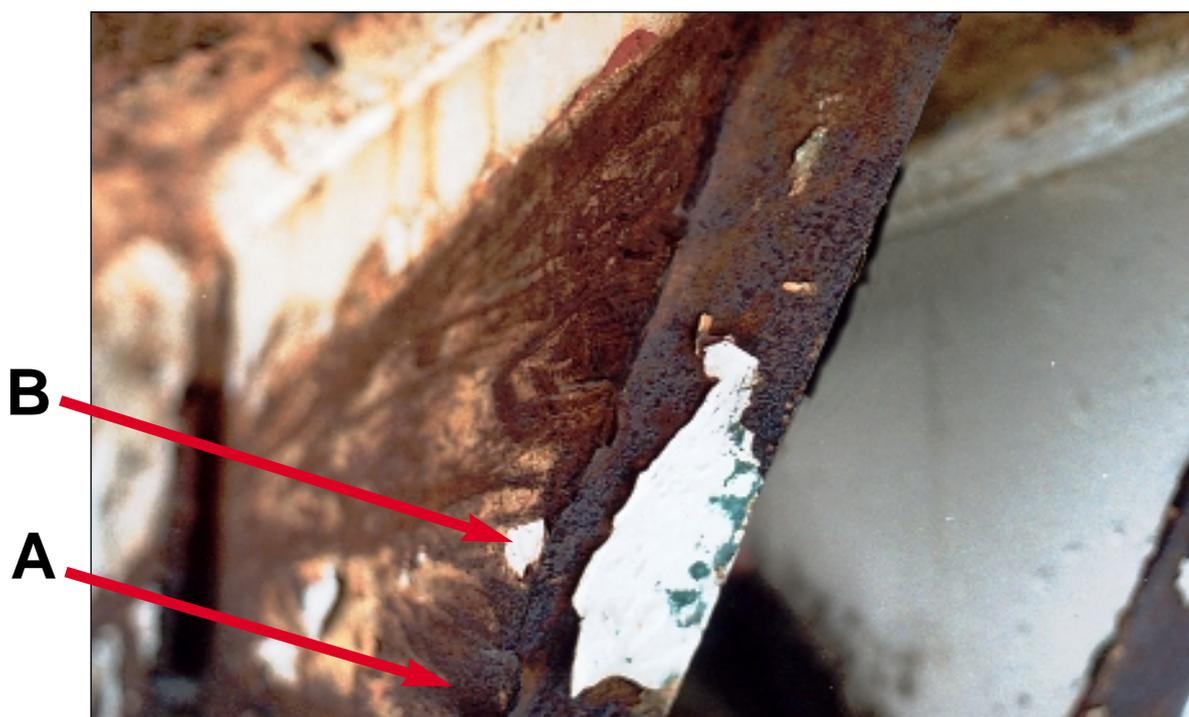
In fact, as seen in picture FG 11 below, the edge that is said to have cut through the deck beam is razor sharp and cannot have cut through any metal. Furthermore, the damage on the side of the hydraulic lug, scratches and plastic deformation, was made in a side and forward direction. That is in the opposite direction that would have been the case if the lug had cut through the deck beam.

FG 13. The port hydraulic lug. Note the plastic deformation shown by arrow A made in the direction of the arrow, and the sharp edge shown by arrow B. Note also that there is paint on the very edge of the lug also shown by arrow B. (This picture can be compared with the German Expert Group picture E9 on the next page, where the complete lug is shown.)

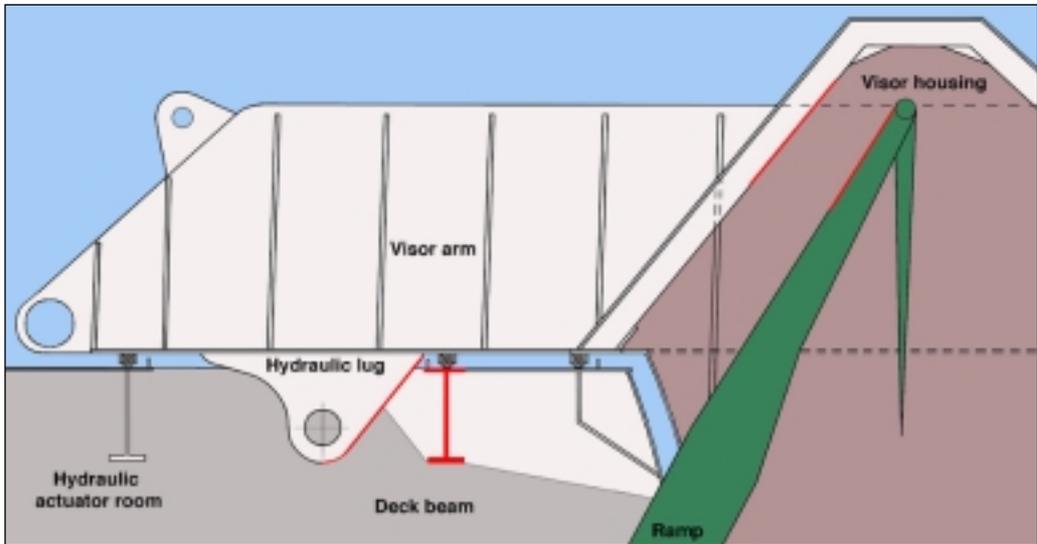
FG 14. Visor and ramp in correct position. Visor arm hinges and hydraulic actuator are not shown.

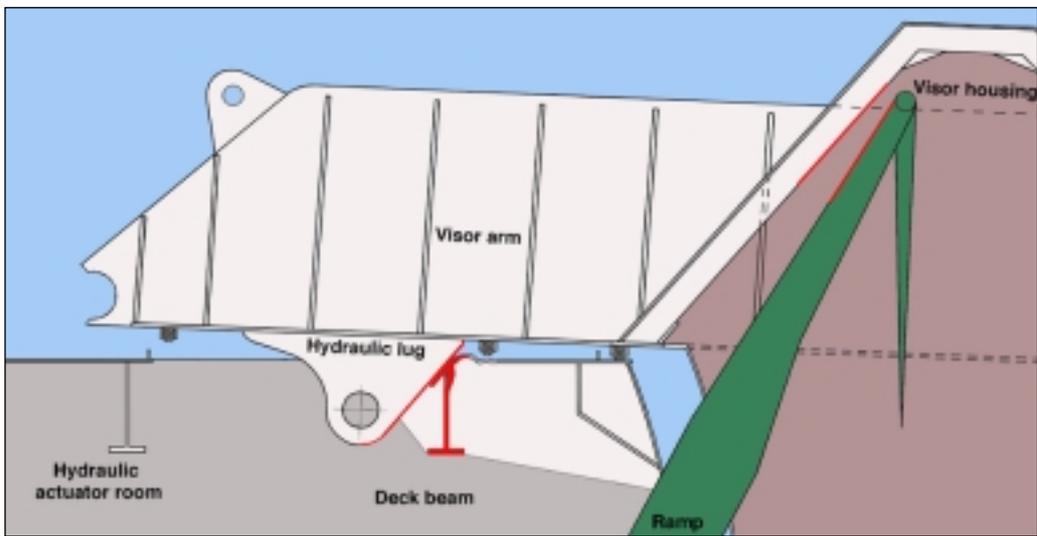
FG 15. The hinges broke and the visor fell forward and hit the deck beam that was bent and deformed but not cut.

If the hydraulic lugs had cut through the deck beam, the beam would have been bent, causing damage to the foredeck and the construction in general. The force needed to break through the beam would therefore rise to close to the ultimate tensile stress, the necessary force of  $8400 \text{ mm}^2 \times 400 \text{ N/mm}^2 = 3360000 \text{ N}$  or 343 tons, and this is only on one side. No damage can be seen on the foredeck (railings in the deckplating following the "cuts", with a distance of approximately 100 - 150 mm, are perfectly intact), and no damage can be seen on the beam where it appears in the "ramp tunnel" into the car deck (which is just 100 millimetres away from the cuts).

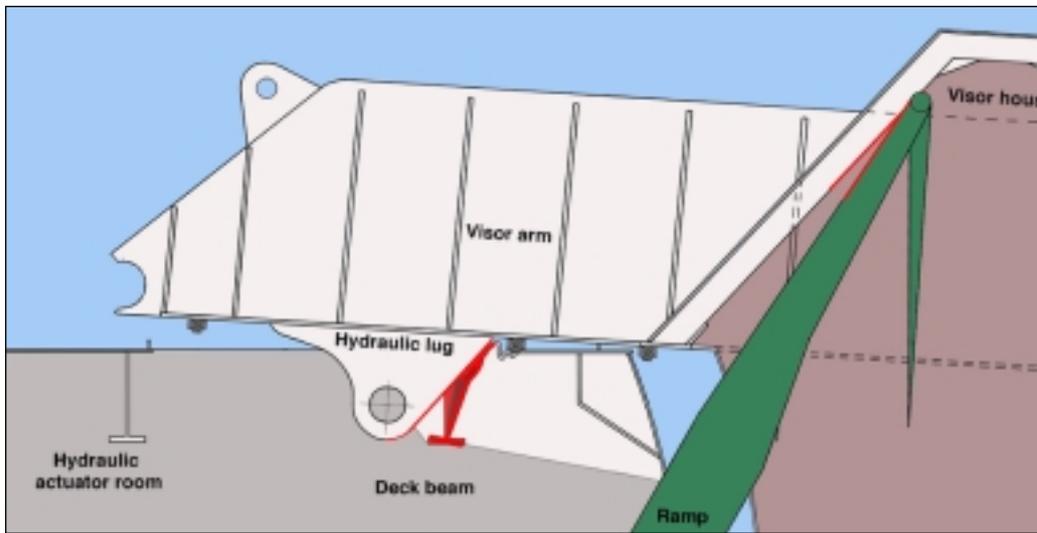
FG 16. The visor hit the upper part of the ramp and caused only slight damage. The deck beam and ramp prevented the visor falling any further.

The final conclusion is that if or when the visor broke loose for some reason initially, it never can have fallen forward, and that therefore the visor never can have ripped the ramp open.
