## **PRESS RELEASE: LACK OF SAFETY ON PASSENGER FERRIES**

The new High-Speed craft, HSC Gotland, that sails between Nynäshamn-Visby and Oskarshamn is according to the Factgroup highly dangerous in case of a fire on board. The crafts only two evacuation stations are situated mid-ship on each side at deck 5. Forward and aft of the stations are the passenger accommodation areas, on deck 5 accommodating 292 respectively 260 persons. The forward area is also connected through a staircase to an accommodation area on deck 6 with room for 148 passengers. In case of an emergency all passengers are to be evacuated from the two station's mid-ship at deck 5. No other alternatives, as required by the conventions, exists. The accommodation areas on deck 5 are separated by manual smoke tight doors adjacent to the evacuation stations.

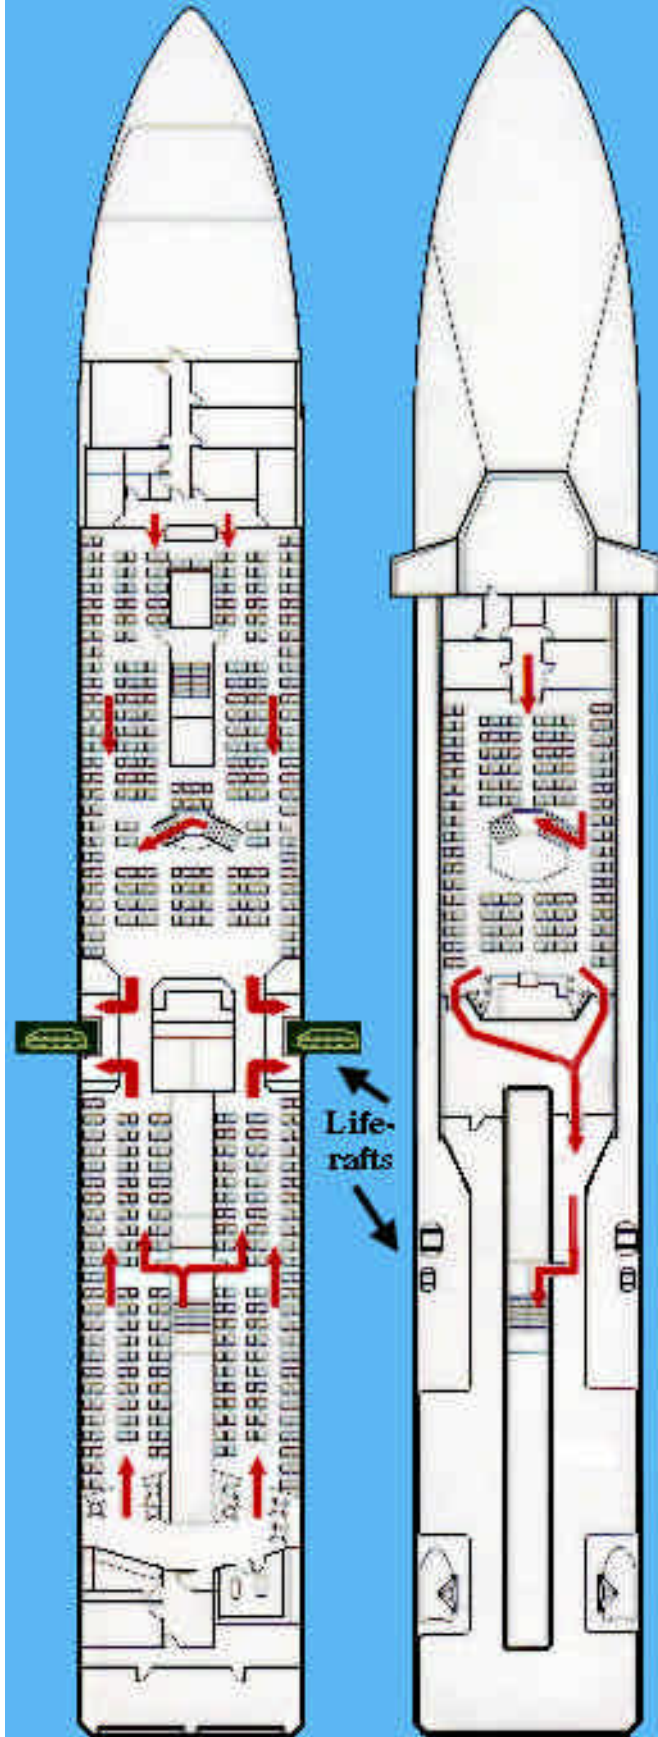
Deck 5

In case of a fire, the smoke tight doors shall be closed providing safe areas for the passengers and crew. The construction of the doors shall be smoke tight during the time the zone is certified for. Unfortunately the doors have been places between two doors leading in to the evacuation room on each side of the craft. This provides for a new open passage for the smoke (and fire) through the evacuation room if the forward and aft zone are to be evacuated in the same time. Please see enclosed plan of the craft and illustrations on page 2-4 showing this situation.

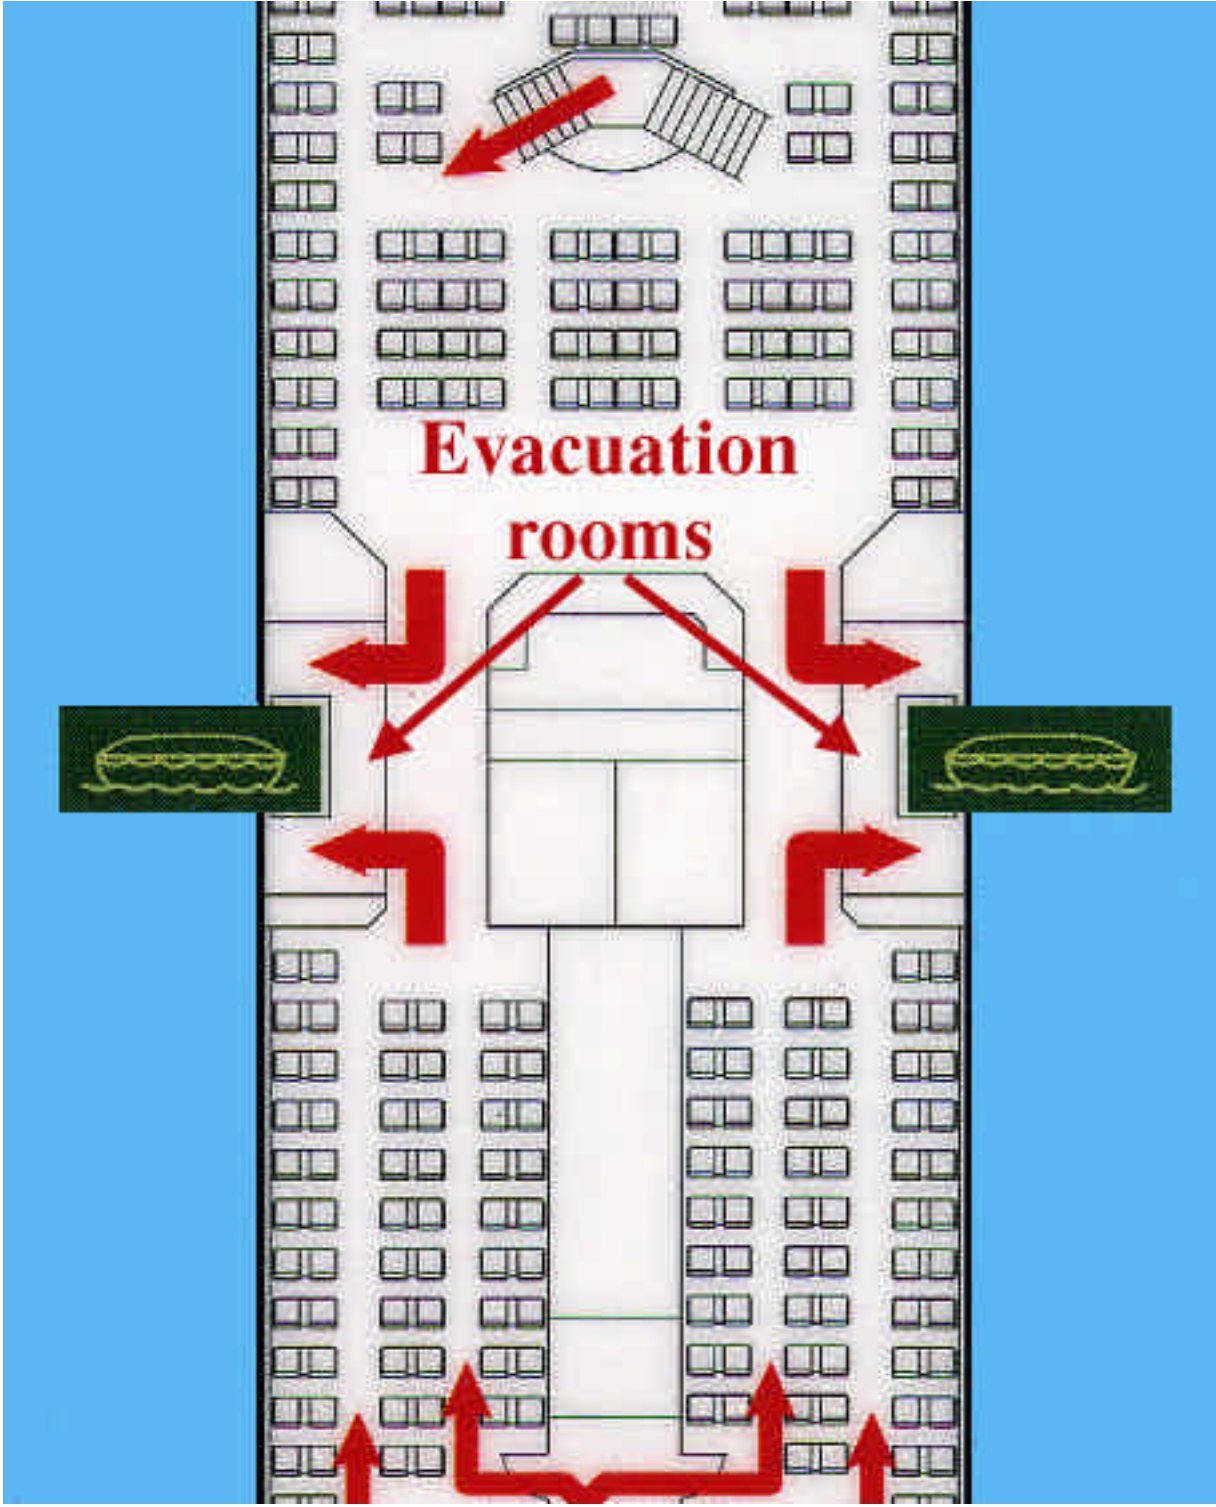
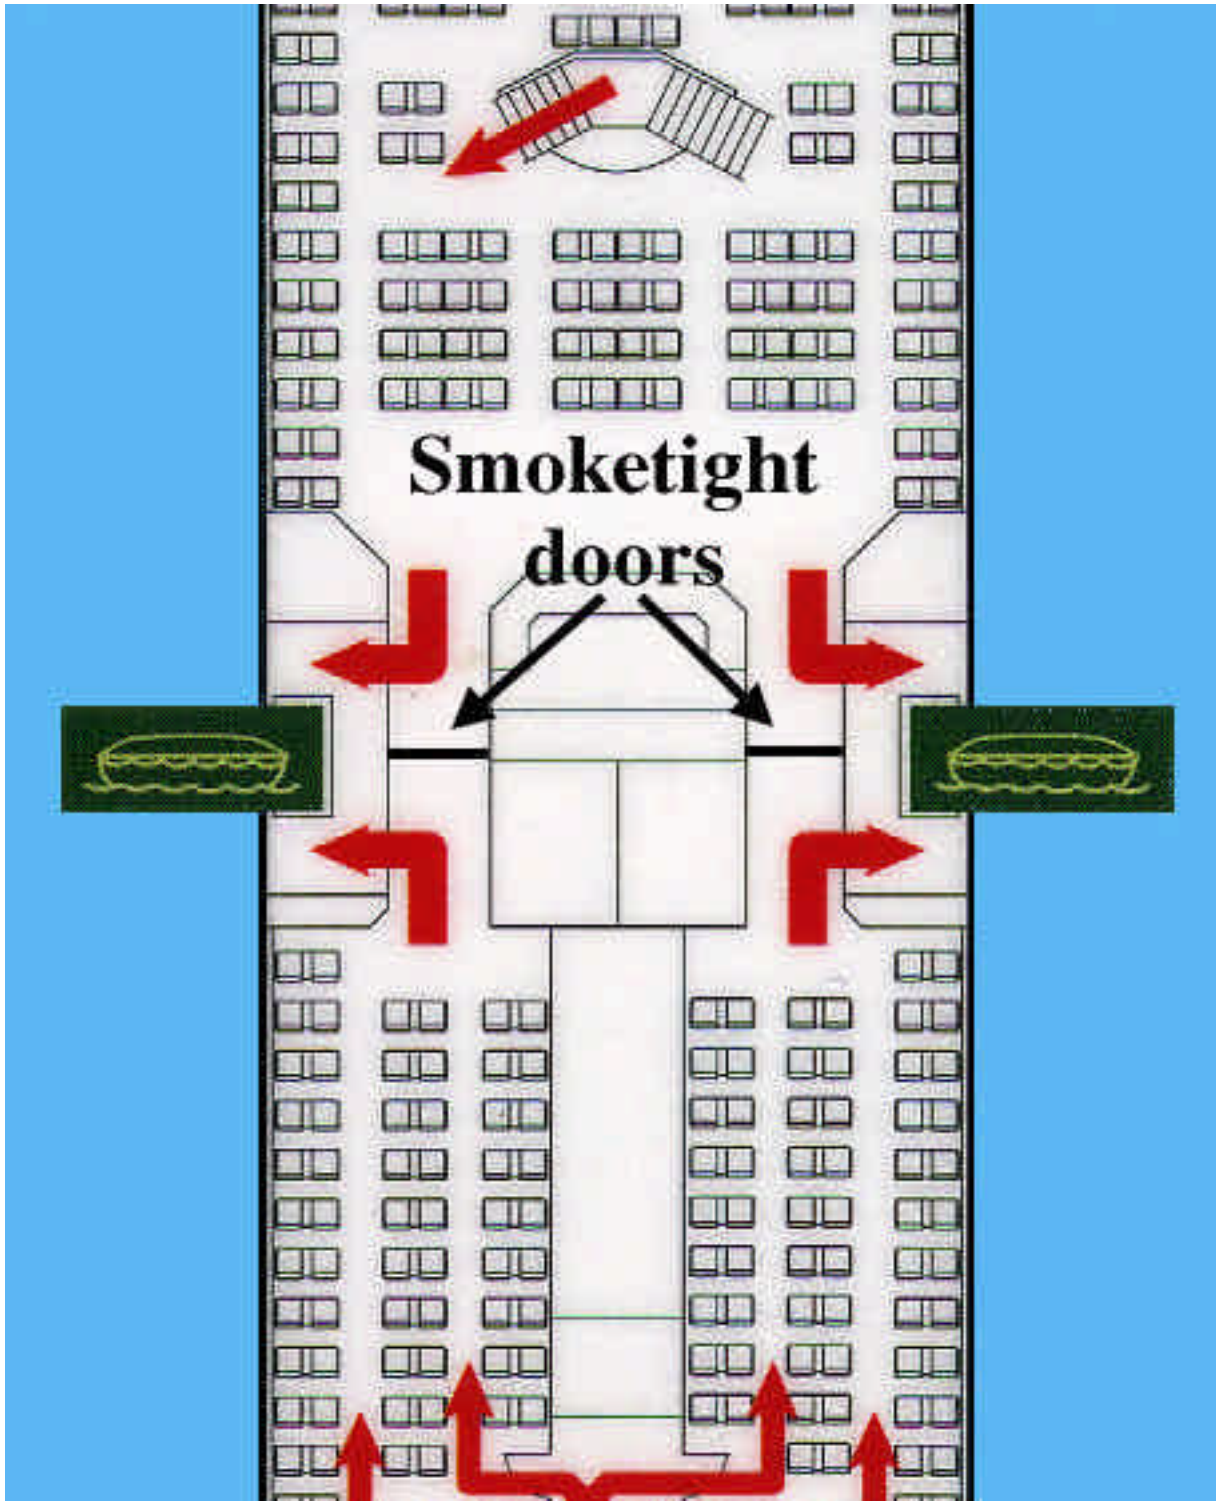
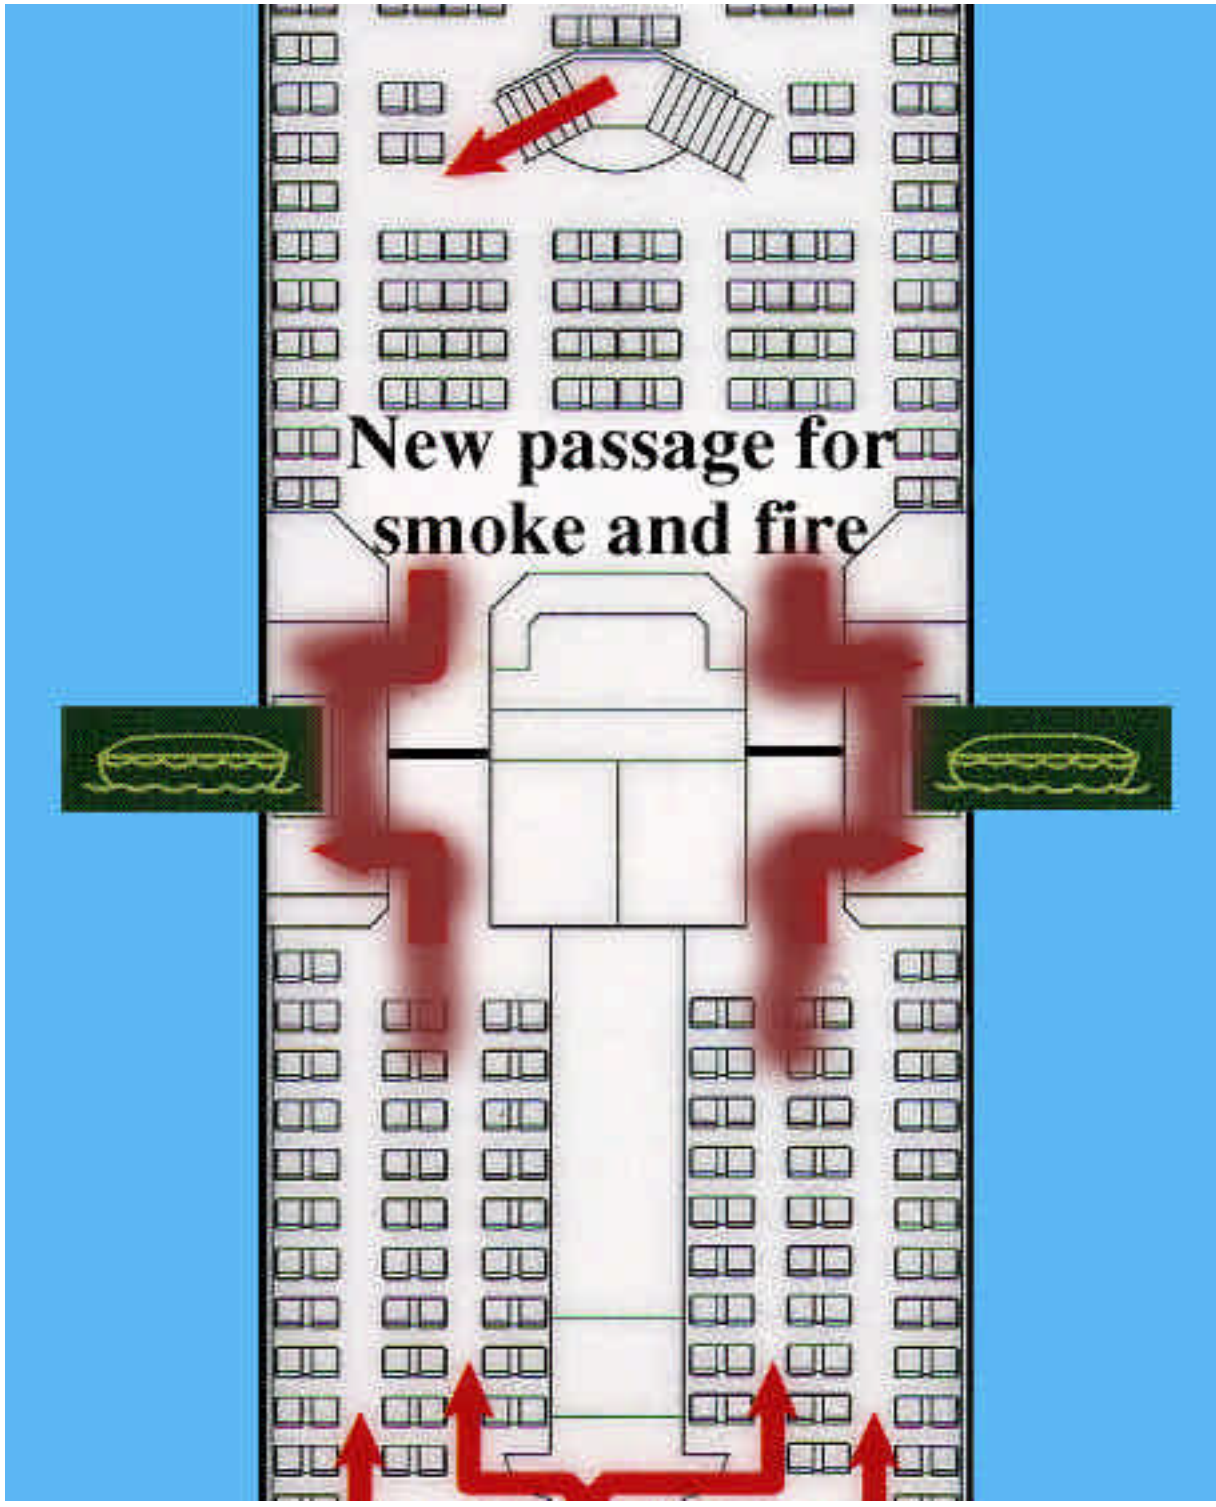
In case of a fire close to the evacuation stations, or even worse, in one of the stations, all possibility to evacuate the passengers may be lost. The requirements of evacuation paths in each end of a passenger zone leading to safe areas and evacuation stations or survival crafts are not fulfilled. No such alternative exist.
