# Research Study on the Sinking Sequence of MV Estonia

WP2.2 Definition of foundering scenarios  
WP3.5 CFD Computations and validations  
WP4.1 Comprehensive modelling of MV Estonia

Project No.: *SaS0603-VIES01*  
Reference No.: *VIES01-RE-001-AJ*  
Report Date: *09 September 2006*  
Report Type: *FINAL*  
Report Status: *CONFIDENTIAL*

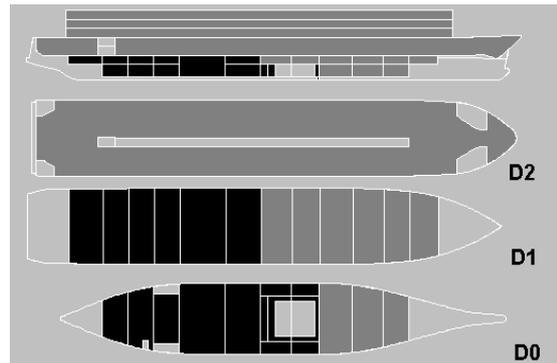
Figure 6: Aft spaces (AS) below CD flooded

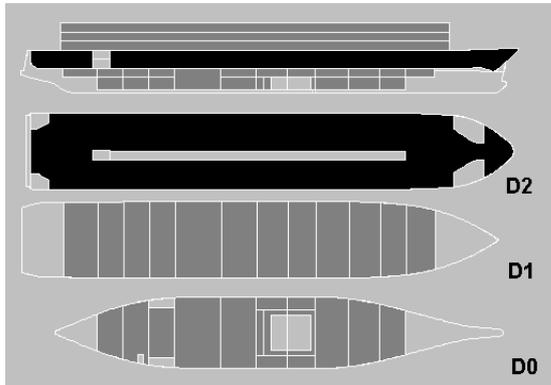
Figure 4: MV Estonia with Car Deck (CD) spaces flooded

Deriving from the above, the process of foundering can be analysed by focusing on some hypothesised intermediate stages of flooding and close examining the effect of free surfaces. In this respect, Figure 8 demonstrates that due to free surface effect, flooding of some 2,000 tonnes of water on the Car Deck results in heel angles of approximately 38deg, whereby the accommodation Deck 4 becomes submerged. Assuming that flooding of Decks 4, 5 and 6 happens instantaneously, as is the traditional naval architecture practice, the GZ curve at this point becomes negative, the vessel loses her stability and subsequently tips upside

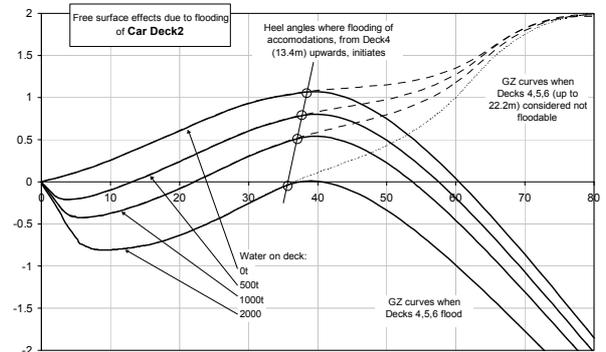
Figure 8: Free surface effects due to flooding of CD

Finally, by combining the information in Figure 8 and Figure 11, it can be indisputably deduced that for the vessel to stay in stable equilibrium with heel angles in excess of 40deg, that is to lie on her side, flooding of accommodation Decks 4, 5 and 6 must have taken place

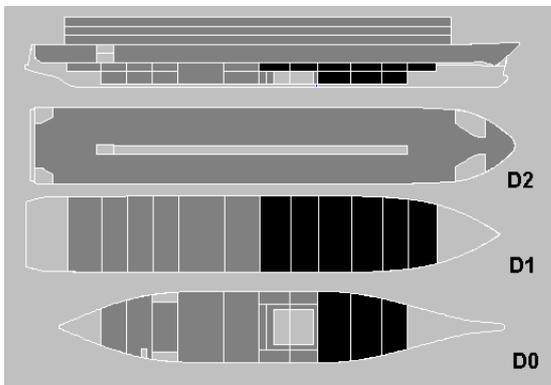
Figure 5: Forward spaces (FS) below CD flooded

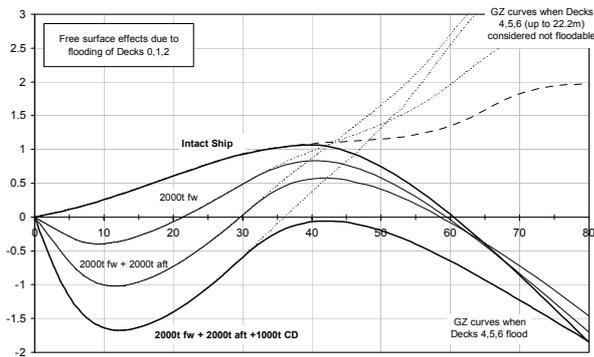
Figure 11: Free surface effects due to flooding of FS, AS and CD

It can be inferred from these arguments that flooding of either forward or aft spaces below the car deck cannot induce heel angles of more than 20-25deg. Note that the stability at equilibrium in each case is higher than the initial stability of intact ship. Moreover, in case of simultaneous flooding of both, the FS and the AS, a heel angle of not more than 30deg will be induced, see Figure 11.
