The Independent Fact Group

Recovery damage to the visor

STATEMENT REPORT

Subject: Recovery damage to the visor - an excerpt from the full report
Type: Statement
By: Johan Ridderstolpe and Björn Stenberg
Status: Proved
Date: 1 May 2000
Version: Report - English

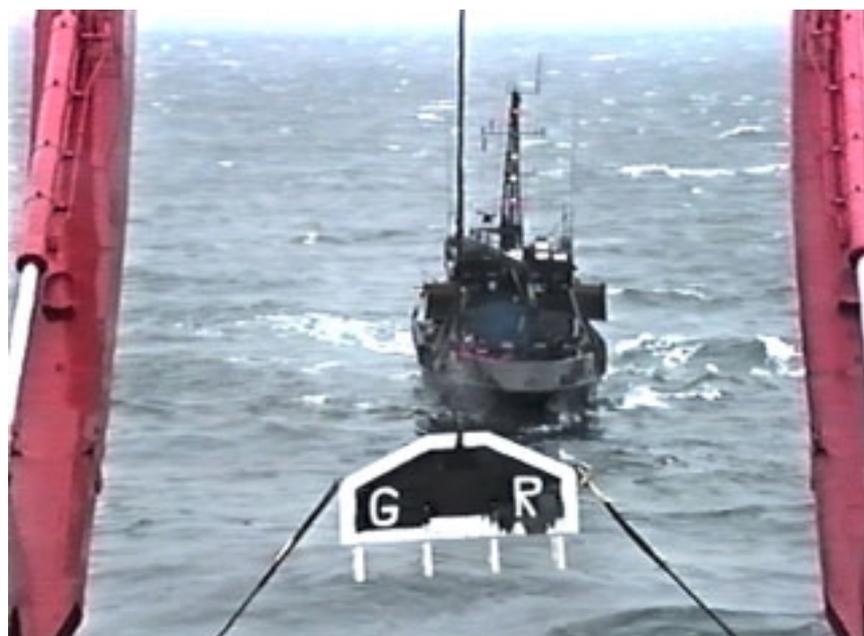
Picture 4. The picture shows the yoke hanging over the water at the first attempt to recover the visor. In the background, HMS Furusund.
